**PHOTOGRAPHIC
INTERPRETATION
REPORT**

**UNIQUE, POSSIBLE WEAPONS-RELATED FACILITIES
AT PAI-CHENG WEAPONS TEST RANGE
CHINA**

NOVEMBER 1970
COPY NO 117
9 PAGES
PIR-069/71

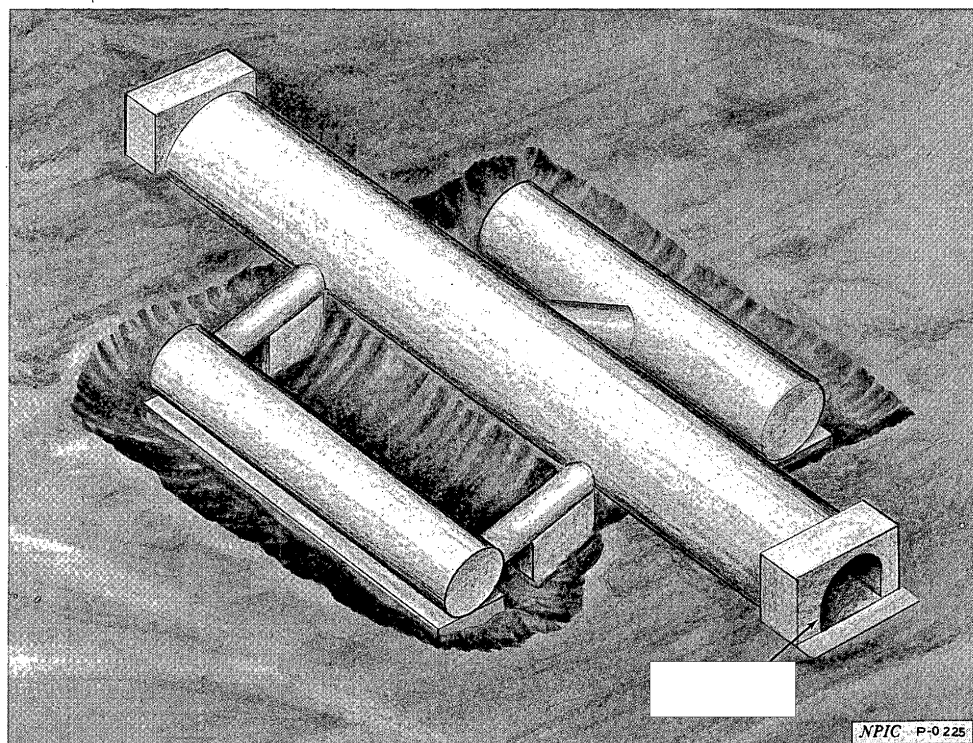
FIGURE 6. COMPOSITE PERSPECTIVE OF UNITS 2 AND 3 AT FACILITY A.

The tubular conduits or passageways connecting the major structures are supported on beveled concrete blocks.

9. Construction of the structural units at facility A had progressed [redacted] to the point where the basic shapes of the units were evident. Two of the units, designated units 2 and 3, respectively, are similar (Figures 4 and 6). Each consists of a concrete arch-roofed building and cylindrical, tank-like structures on each side of and parallel to the arch-roofed building. Tubular conduits or passageways connect the tank-like structures to the arch-roofed building.

10. The arch-roofed building, which was built on a concrete slab near grade level, has rectangular probable reinforced concrete entrances at both ends. The cylindrical tank-like structures, which also were constructed or installed on concrete slabs, are housed in excavations considerably below grade level. One of the cylindrical structures has a single large tubular conduit or passageway connecting it to the arch-roofed building. The cylindrical structure on the opposite side of the arch-roofed building is connected to the arch-roofed building by two smaller conduits or passageways. All of the tubular conduits or passageways are supported on beveled concrete blocks and set at an angle down from the arch-roofed building to the cylindrical tank-like structures.

13. Plan view drawings with dimensions of the structural units at facility A are included in Figure 7. A composite perspective of units 2 and 3 is shown in Figure 6.

14. The only apparent structural difference between units 2 and 3 is a difference in lengths of corresponding cylindrical tank-like structures that are connected to the arch-roofed building by the two conduits or passageways (Figure 7).
